## AIR-LAUNCHED WINDSONDE

Stephen F. Rohrbough and Lyie E. Koehler  
Honeywell Inc.  
Systems and Research Division  
Research Department  
St. Paul, Minnesota 55113

### FINAL REPORT

Contract Monitor: James F. Morrissey  
Aerospace Instrumentation  
Laboratory

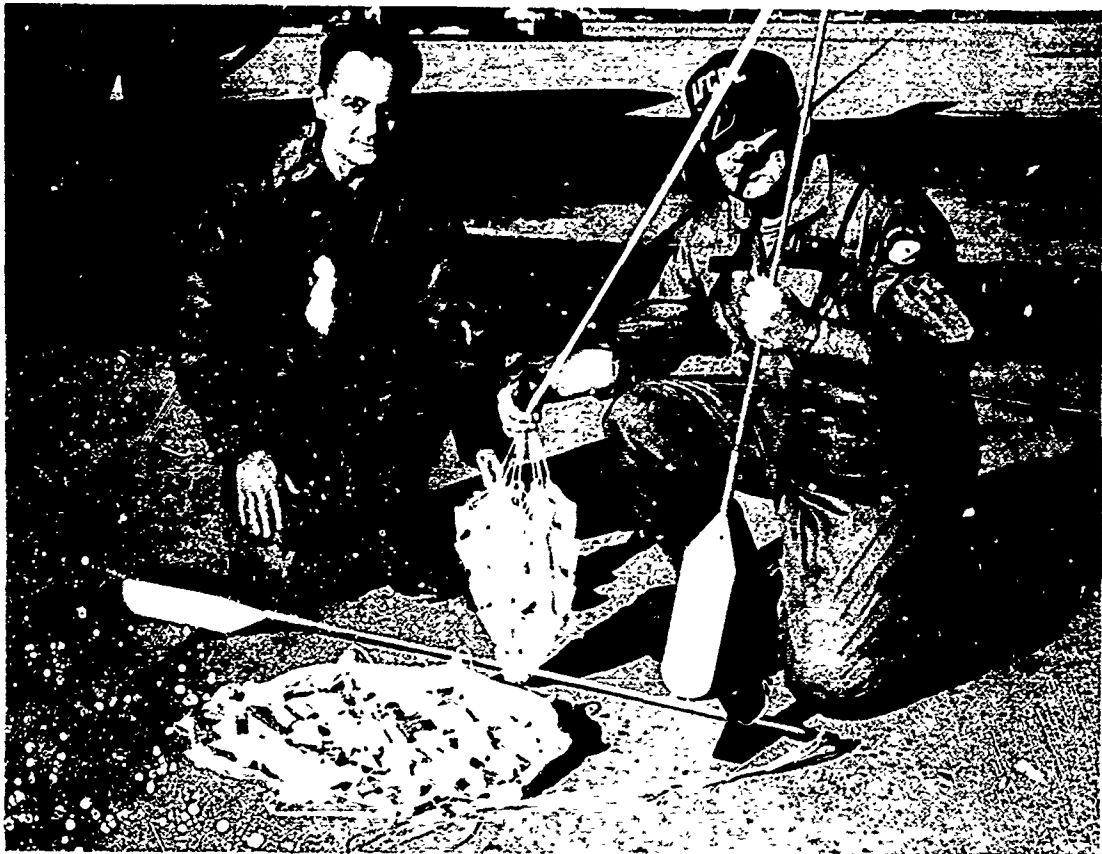
Figure 12. Dummy Windsonde Models for Shackle Test

On 1 October 1968, two dummy sondes were prepared for ejection from a C-130 to test the shackle retardation and release scheme (see Figure 12). Both sondes were quite similar to actual Windsondes physically. The plane was depressurized and flown at 30,000 feet off the east coast CONUS. Just as the first

test sonde was being pitched out, the turbulence in the cargo area whipped the parachute around. In doing so the tail boom was bent and the shackle was pulled, shearing the wire and releasing the parachute.

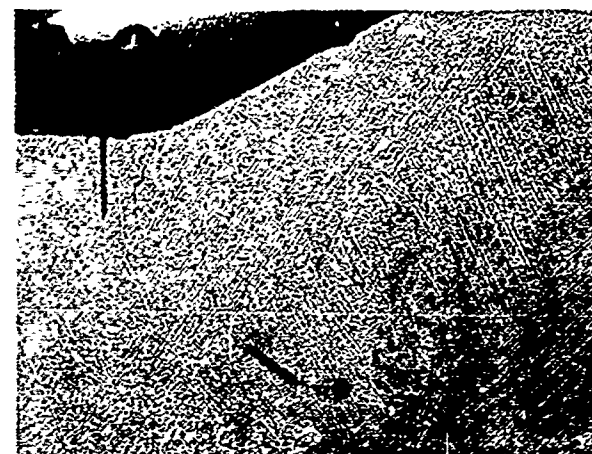
Figure 22. Sonde Ejection Sequence for April 1969 Flight

Each of the three drops went off successfully (see Figure 22). On the first drop, the radar was able to track the parachute as it left the plane but was unable to see the sonde fall from the parachute. On the second drop, sonde 4, the radar saw the parachute as it left the plane and was able to follow the sonde as it fell to the ground. On sonde No. 5, the radar was unable to locate the sonde, and only tracked the parachute. Sonde No. 3 had no gyroscope signal; the other two units appeared to have good data all the way. Permission was obtained from mission control personnel allowing the ground station operators to look for the sondes. However, they were unable to find either the sondes or their parachutes and protective tubes.
